Manhole Inspection Summary

Manhole # S33S__005MH

Insp Date: **2/5/08 3:27 PM**

Location Address: **race st**

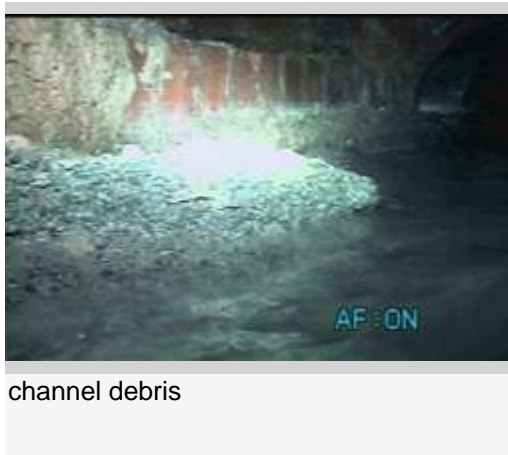
Misc

channel debris

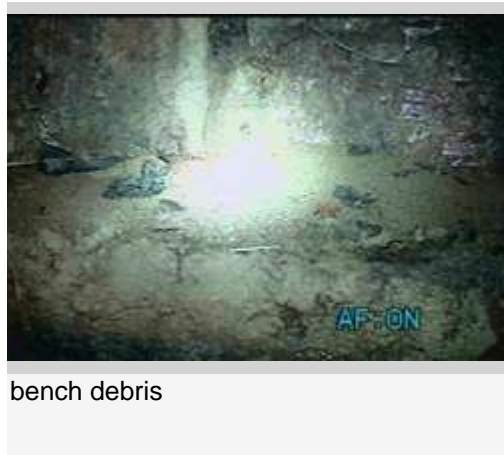
Defect 2

Condition: ☐ Sound ☐ Cracked ☐ Root Intrusion ☐ Deteriorated ☐ Leaks ☒ **Debris**

bench debris

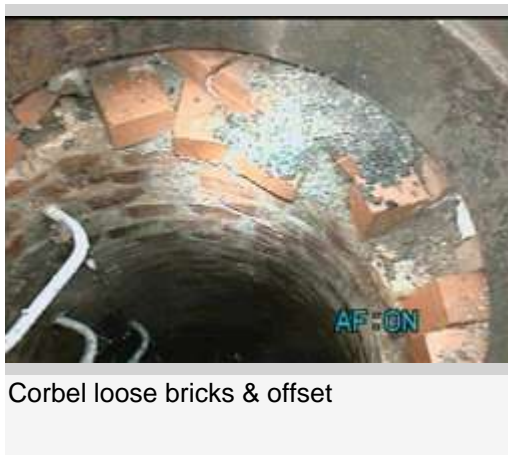
Defect 1

Condition: ☐ Sound ☐ Cracked ☐ Root Intrusion ☒ **Loose Brick** ☐ Deteriorated

Corbel loose bricks & offset

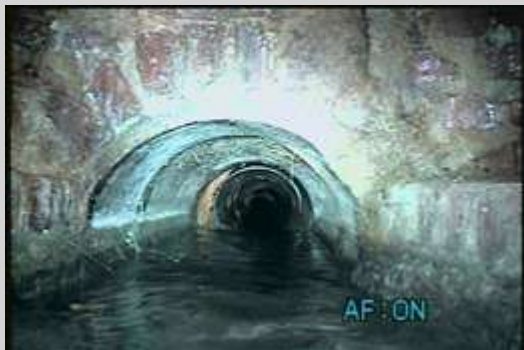
12 O'Clock Outflow

18 in. Circular Gravity Sewer
Pipe Out @ 12 O'Clock

Invert Depth: **10.60** (ft.) Flow Characteristics: **Fast**

Deposits: ☒ None ☐ Mud ☐ Sludge ☐ Debris ☐ Grease

Infiltration: **None** Pipe Seal Cond: **Unknown**

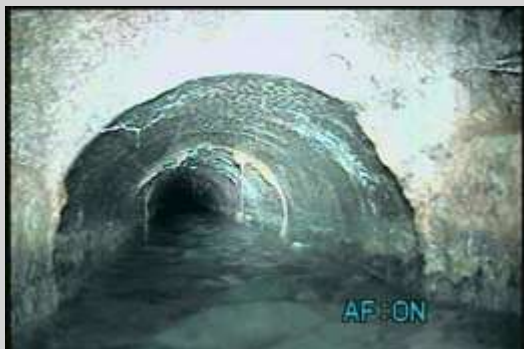
6 O'Clock Inflow

18 in. Circular Gravity Sewer
Pipe In @ 6 O'Clock

Invert Depth: **10.40** (ft.) Flow Characteristics: **Fast**

Deposits: ☒ None ☐ Mud ☐ Sludge ☐ Debris ☐ Grease

Infiltration: **None** Pipe Seal Cond: **Unknown**
